Inspection Report

Property Address:
11535 Wellman Dr.
Riverview Fl. 33578

SEC Inspection Services

Date: 5/4/2009	Time: 04:30 PM	Report ID: 1005
Property: 11535 Wellman Dr. Riverview Fl. 33578	Customer: Mr. Ron Centers	Real Estate Professional:

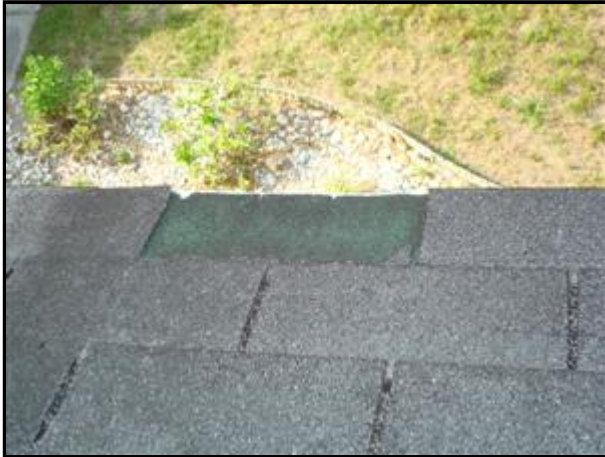
1.0 Picture 1

(1) The roof covering is missing shingles in multiple areas at the front of home. Mainly to the left of the gable and in two areas on the gable. Roof covering will need replacing before 3 years. A qualified contractor should inspect and repair as needed.

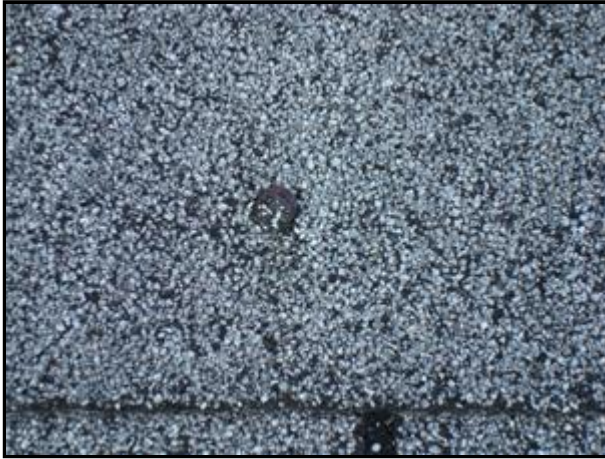
1.0 Picture 4

(2) The roof covering is damaged by nail pops on all four sides of the home. There was approximately five nail pops that have been identified on the roof. This damage should be repaired or replaced. A qualified contractor should inspect and repair as needed.

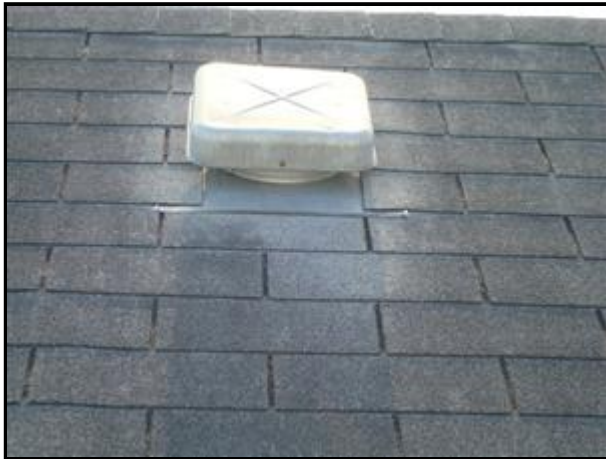
1.0 Picture 7

(3) The roof vents were installed improperly at the left and right sides of the home as well as rear of home. This does not appear adequate. It should be properly repaired or replaced. A qualified contractor should inspect and repair as needed.

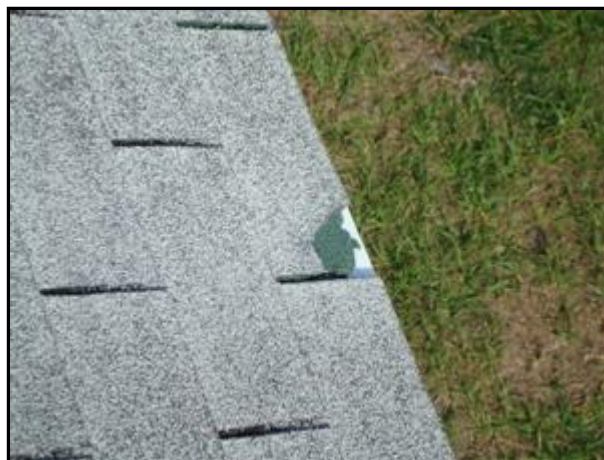
1.0 Picture 10

(4) The roof covering is starting to crack and deteriorate at the starter strip. It should be replaced as soon as possible. A qualified contractor should inspect and repair as needed.

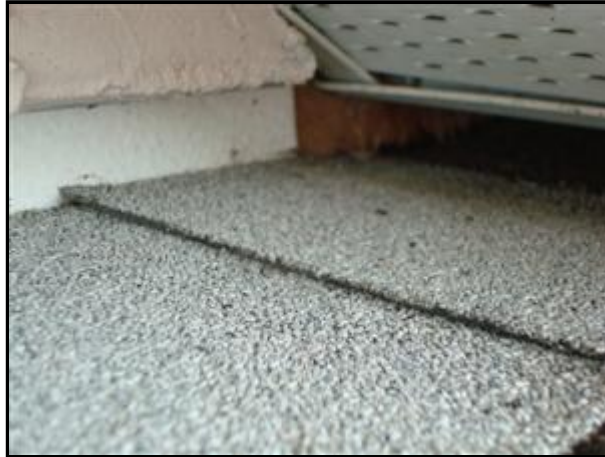
1.1 Picture 1

The flashing is missing underneath the right side corner of the gable. Repair or replace as necessary..

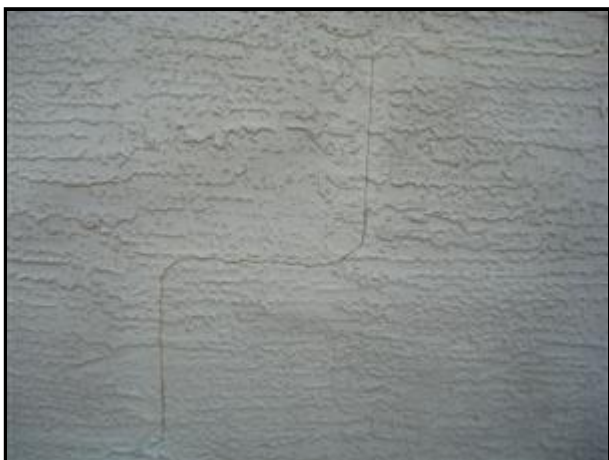
2.0 Picture 1

(1) The Stucco coating on the exterior has step cracking in various areas around the home. The cracking of the stucco is also on the chimney. Further deterioration can occur if not corrected. A structural engineer should be contacted to do further testing.

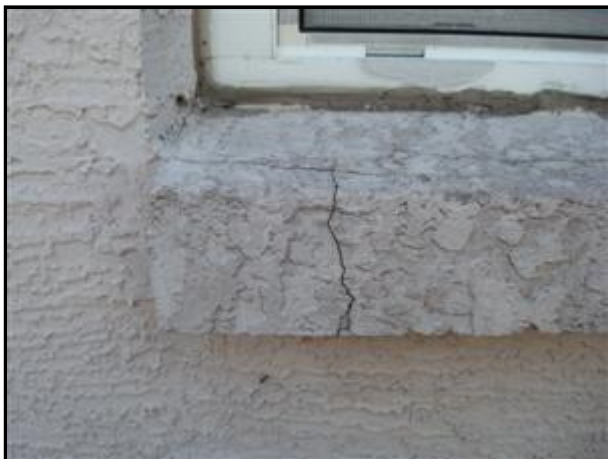
2.2 Picture 1

(1) The sill plate damaged at multiple windows. Further deterioration may occur if not repaired. A qualified contractor should inspect and repair as needed.

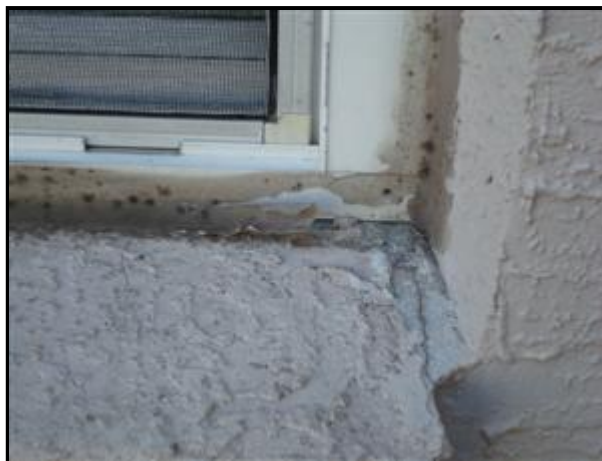
2.2 Picture 3

(2) The sealant around the window frames are starting to deteriorate. Further deterioration may occur if not repaired. A qualified person should repair or replace as needed.

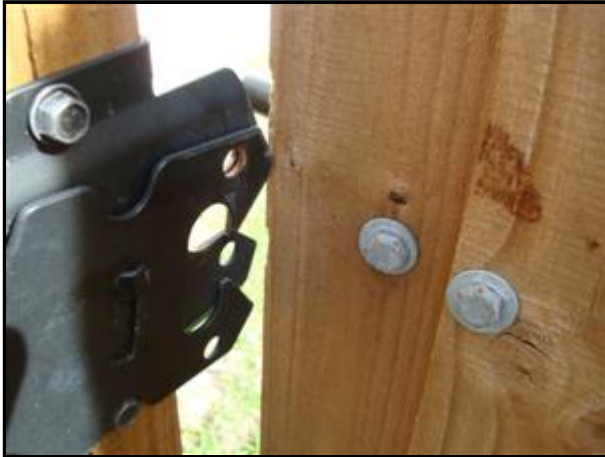
2.3 Picture 1

The fence door to the right of the home needs adjustment to latch properly. The fence door latch to the left of the home has become partially unfastened. This is a maintenance issue. A qualified person should repair or replace as needed.

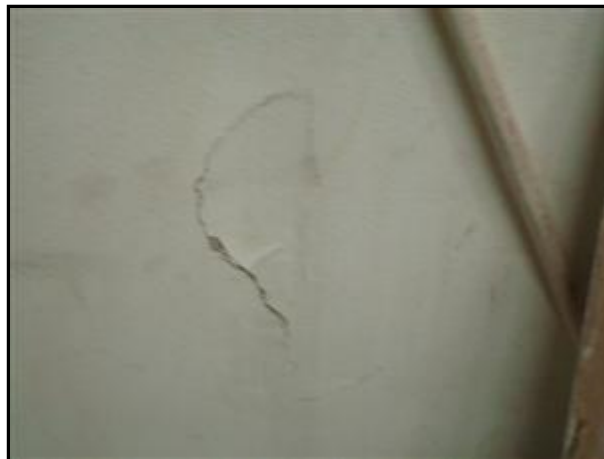
3.1 Picture 1

(1) The sheetrock underneath the air handler is damaged. While this damage is cosmetic, it needs to be repaired. A qualified person should repair or replace as needed.

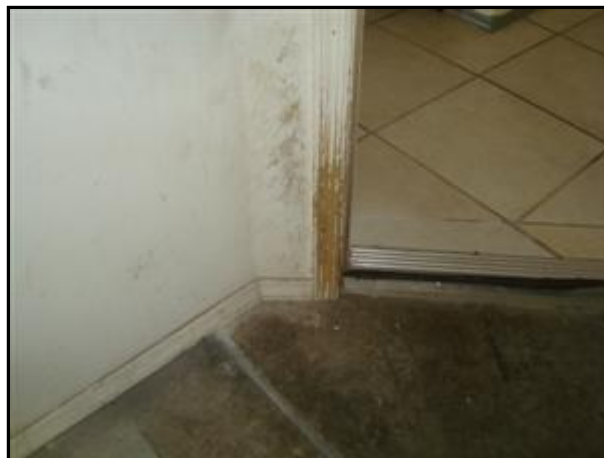
3.1 Picture 2

(2) The wood trim around the door entering from the garage to the home is damaged. The plaster around the wood trim is also damaged. This damage is considered cosmetic. A qualified person should repair or replace as needed.

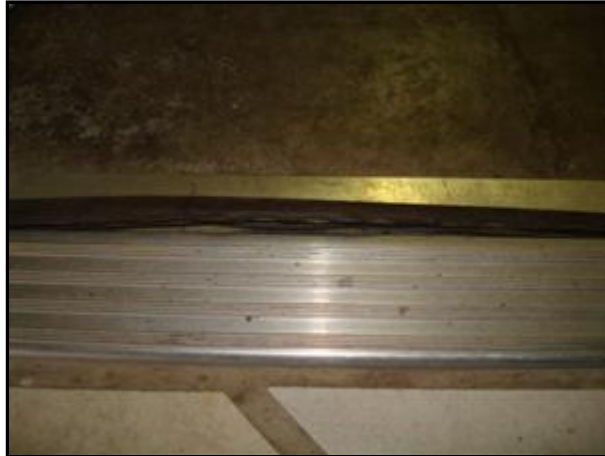
3.3 Picture 1

The door leading from the garage to the kitchen has a torn weather strip at the bottom. This is a maintenance issue and is for your information. A qualified person should repair or replace as needed.

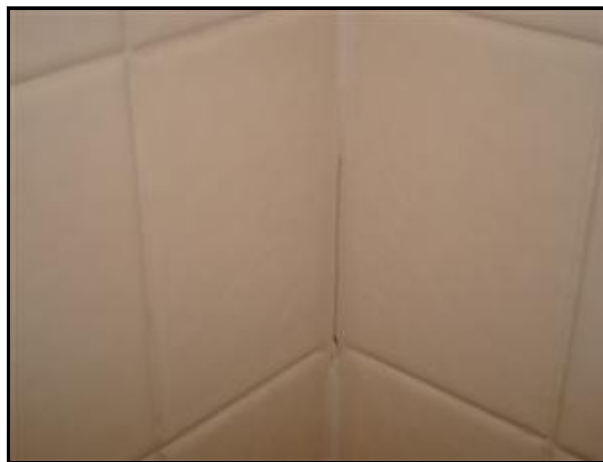
4.1 Picture 1

(1) The tile surround at the bathtub wall is deteriorated and needs repair or replacement. The wall board and framing may need repair (not visible). I recommend repair or replace using a qualified contractor.

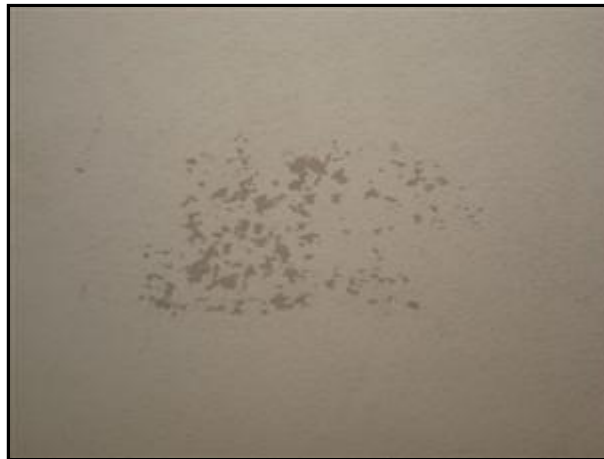
4.1 Picture 4

(3) The plaster on the wall is damaged at the Guest Bedroom. This damage is considered cosmetic. A qualified person should repair or replace as needed.

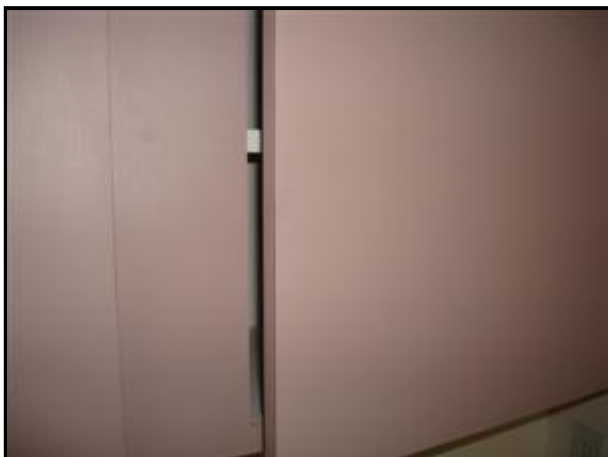
4.3 Picture 1

Cabinet door (s) need adjusting in various areas where doors don't close completely. This is a cosmetic issue for your information. Recommend repair or replace as necessary.

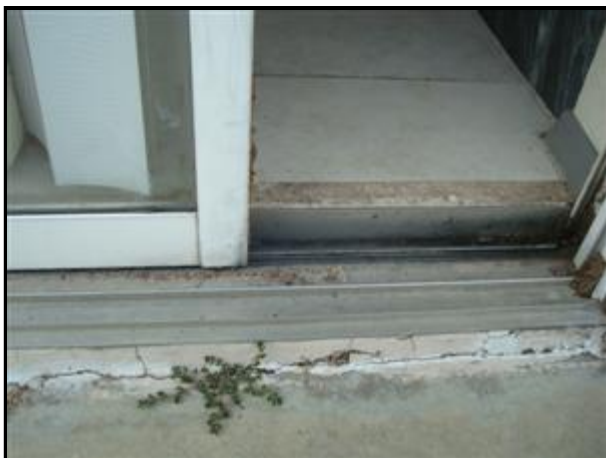
4.4 Picture 1

The Sliding doors going from the living room to the backyard fall off their respective tracks when operated. This is considered unsafe and needs correcting. A qualified person should repair or replace as needed.

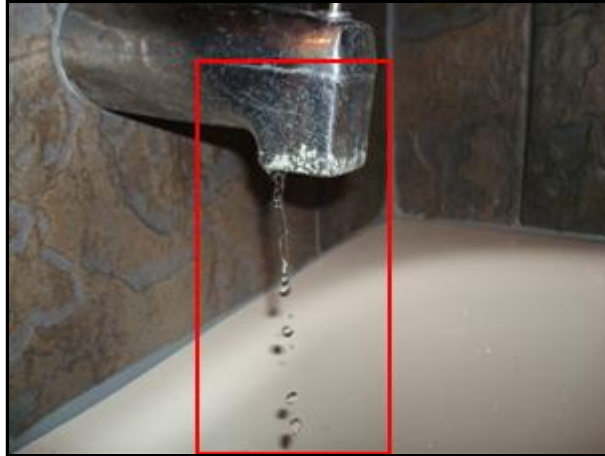
6.1 Picture 1

(1) The tub spout leaks at the master bath. Repairs are needed. A qualified person should repair as necessary.

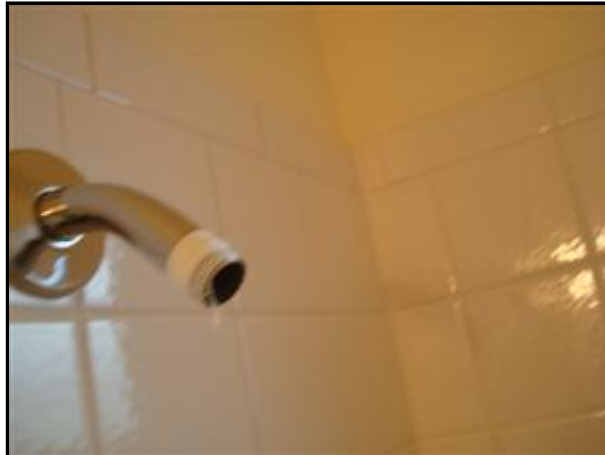
6.1 Picture 2

(2) The shower head is missing at the hall bath. Repairs are needed. A qualified person should repair as necessary.

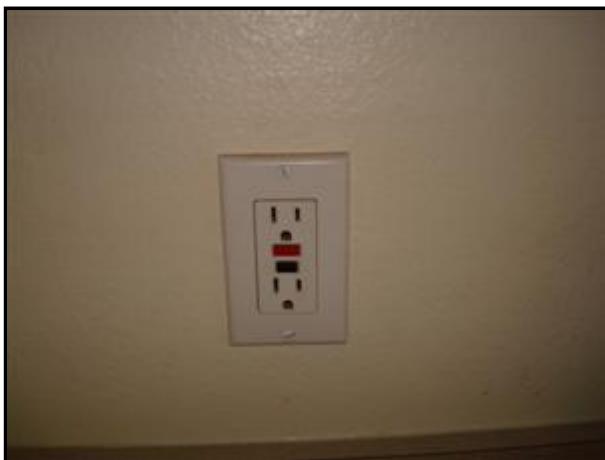
7.1 Picture 1

(1) GFCI (Ground Fault Circuit Interrupter) outlets to the right and the left of the stove won't trip when tested. Electrical issues are considered a hazard until repaired. A qualified licensed electrical contractor should perform repairs that involve wiring.

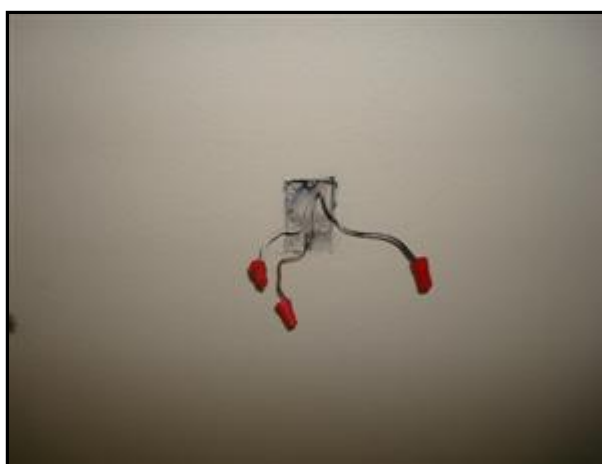
7.1 Picture 3

(2) One electrical outlet is missing in the utility room. Electrical issues are considered a hazard until repaired. A qualified licensed electrical contractor should perform repairs that involve wiring.

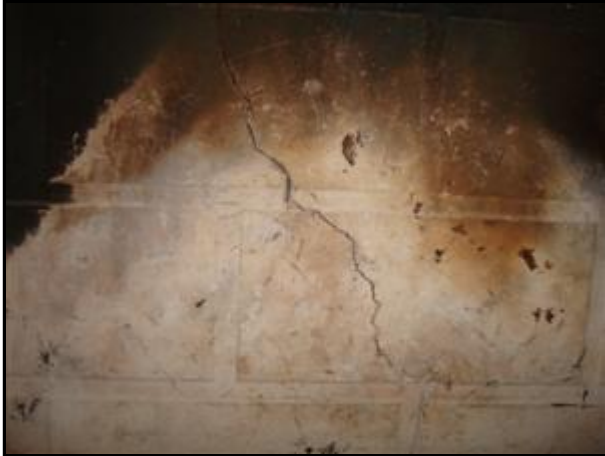
8.5 Picture 1

The fire retardant brick liner in the fireplace is cracked on every side. Repairs should be made so unit works properly. A qualified person should repair or replace as needed.

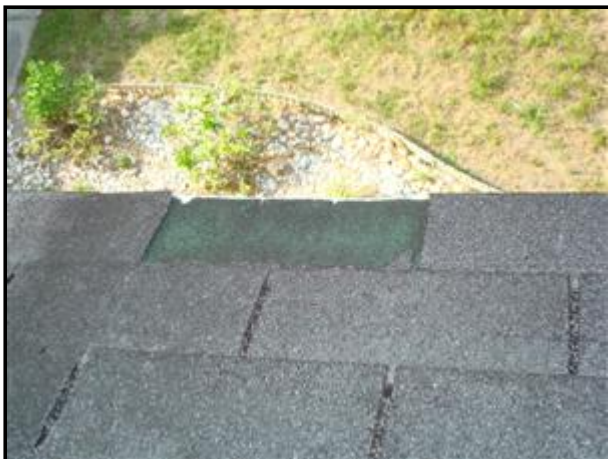
1.0 Picture 1

(1) The roof covering is missing shingles in multiple areas at the front of home. Mainly to the left of the gable and in two areas on the gable. Roof covering will need replacing before 3 years. A qualified contractor should inspect and repair as needed.

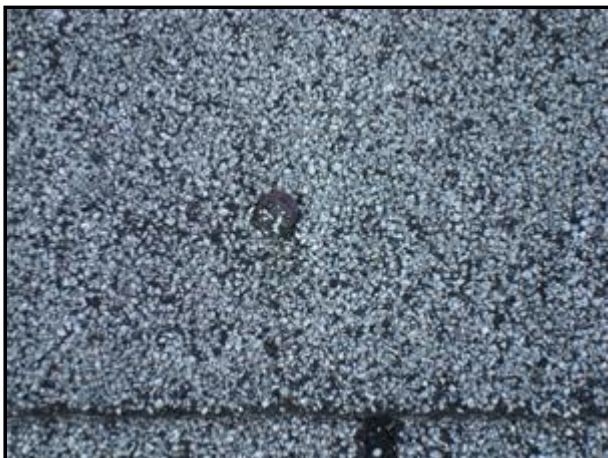
1.0 Picture 4

(2) The roof covering is damaged by nail pops on all four sides of the home. There was approximately five nail pops that have been identified on the roof. This damage should be repaired or replaced. A qualified contractor should inspect and repair as needed.

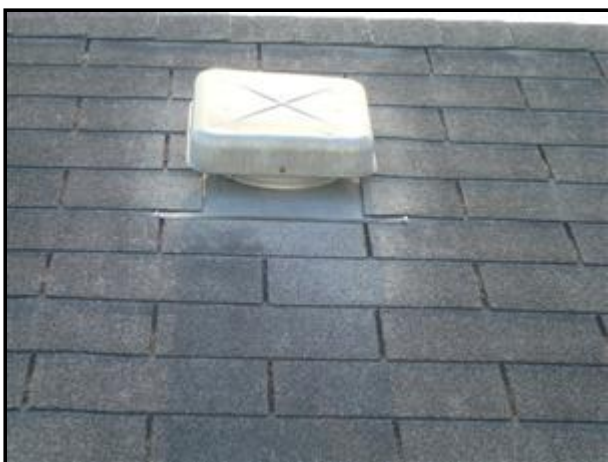
1.0 Picture 7

(3) The roof vents were installed improperly at the left and right sides of the home as well as rear of home. This does not appear adequate. It should be properly repaired or replaced. A qualified contractor should inspect and repair as needed.

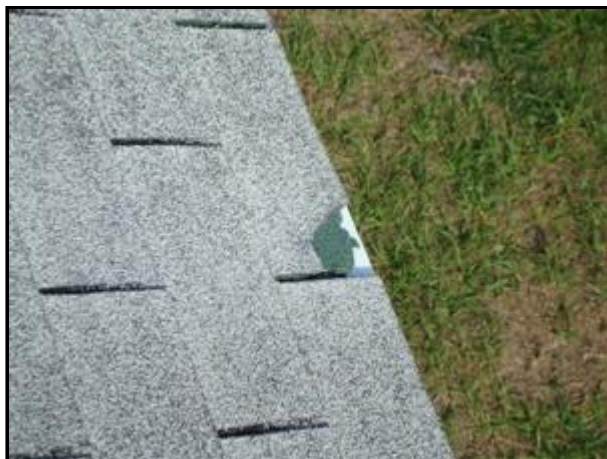
1.0 Picture 10

(4) The roof covering is starting to crack and deteriorate at the starter strip. It should be replaced as soon as possible. A qualified contractor should inspect and repair as needed.

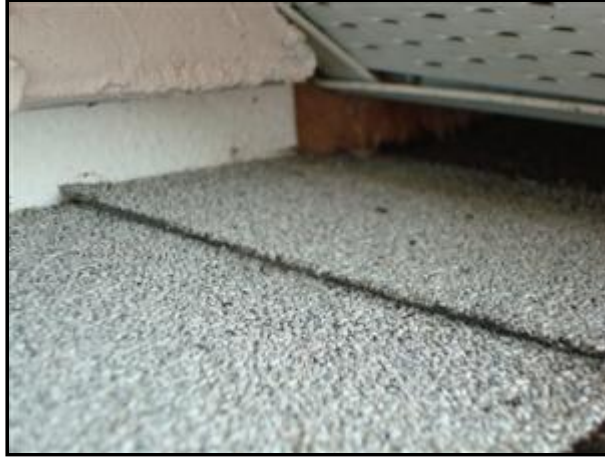
1.1 Picture 1

The flashing is missing underneath the right side corner of the gable. Repair or replace as necessary..

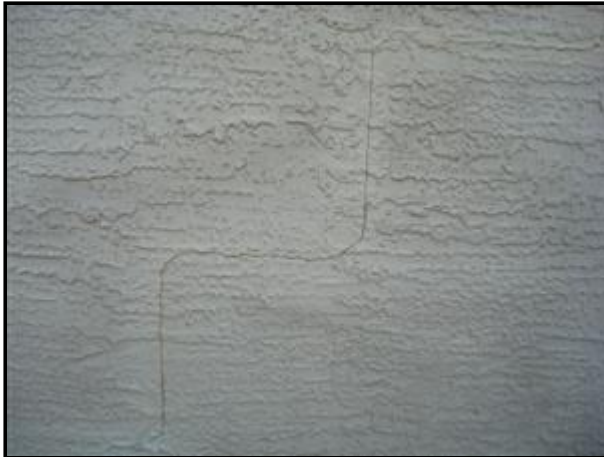
2.0 Picture 1

(1) The Stucco coating on the exterior has step cracking in various areas around the home. The cracking of the stucco is also on the chimney. Further deterioration can occur if not corrected. A structural engineer should be contacted to do further testing.

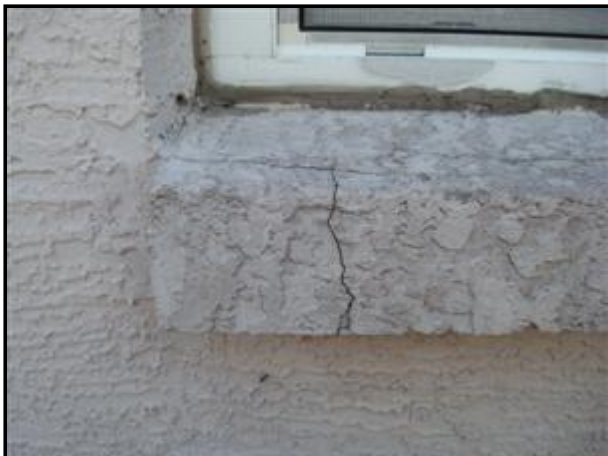
2.2 Picture 1

(1) The sill plate damaged at multiple windows. Further deterioration may occur if not repaired. A qualified contractor should inspect and repair as needed.

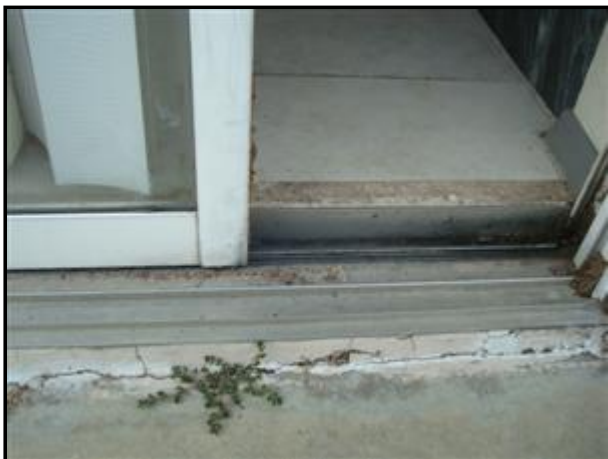
4.4 Picture 1

The Sliding doors going from the living room to the backyard fall off their respective tracks when operated. This is considered unsafe and needs correcting. A qualified person should repair or replace as needed.

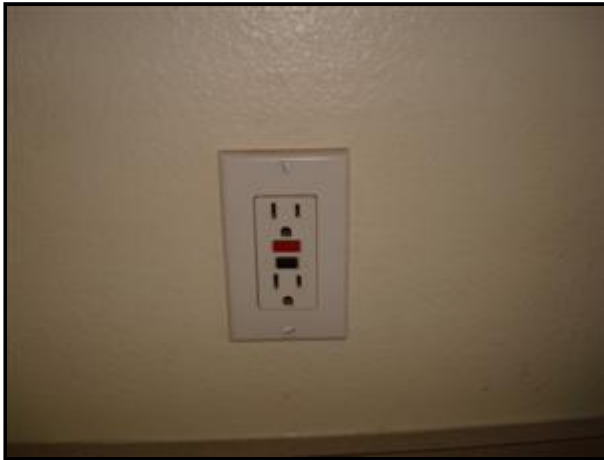
7.1 Picture 1

(1) GFCI (Ground Fault Circuit Interrupter) outlets to the right and the left of the stove won't trip when tested. Electrical issues are considered a hazard until repaired. A qualified licensed electrical contractor should perform repairs that involve wiring.

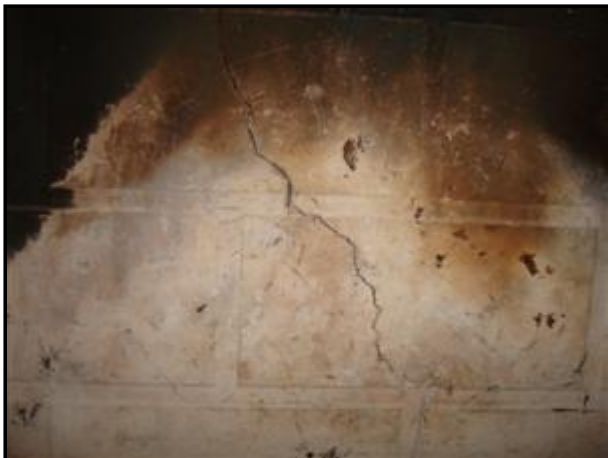
8.5 Picture 1

The fire retardant brick liner in the fireplace is cracked on every side. Repairs should be made so unit works properly. A qualified person should repair or replace as needed.
